Leaks in the vaporizer unit: Still a possibility

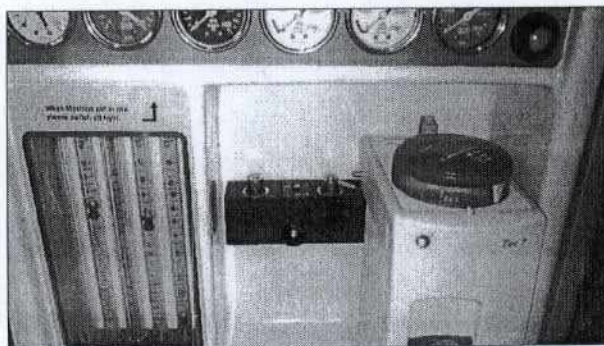
Figure 1: Needle causing the leak

In our case, though a needle was present between the mounting system and vaporizer [Figure 1], it was possible to lock the locking lever and the control dial could be turned on. This led to leakage of fresh gas flow and under-filling of the reservoir bag. Consequences of leaks include alteration in the flow and composition of inspiratory gas and pollution of the operating room air. The former can cause hypoxia, re-breathing or awareness in a patient if not identified and rectified.

In conclusion, detachable mounts are convenient but are a potential source of leak. We recommend that utmost care be taken during dismounting and remounting of vaporizers to avoid damage to them and prevent leaks.
